GENERAL INFORMATION

This section covers the various Pentium® OverDrive® processors.

Summary Table of Changes

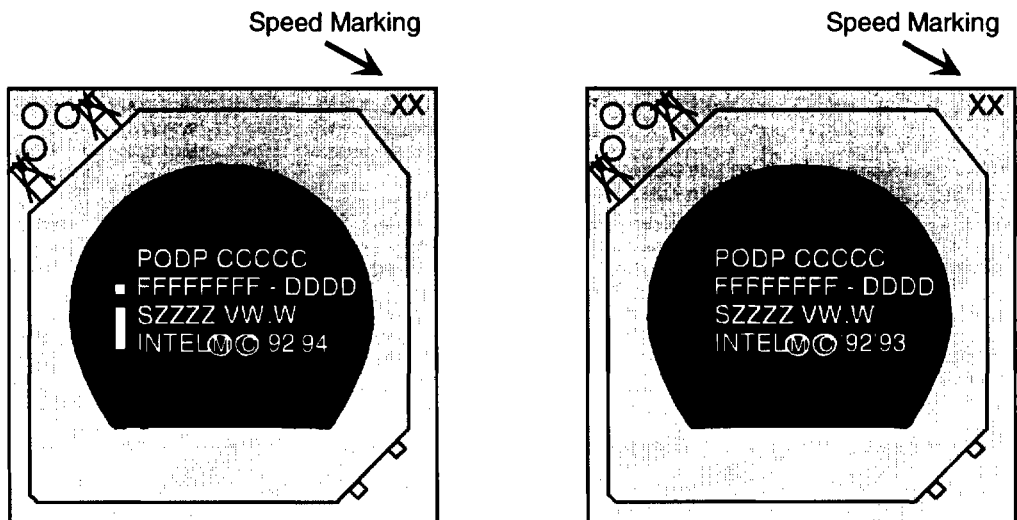
Top Markings

The Pentium OverDrive processor can be identified by the number on the base of the heat sink, under the integrated fan. To remove the fan, squeeze the retaining clips in the upper left corner of the chip and lift up. The figure below shows the laser mark found on the heatsink base of the processor. A marking is also used to indicate the speed of the part and is located in the upper right of the package.

63- and 83-MHz Pentium® OverDrive® processors
for Intel486™ processor-based systems

120/133-, 125-, 150- and 166-MHz Pentium®
OverDrive® processors
